## Long term monitoring of repaired external wall assembly

11th Nordic Symposium on Building Physics, NSB2017, 11-14 June 2017, Trondheim, Norway

Susanna Ahola<sup>a\*</sup>, Jukka Lahdensivu<sup>b</sup>

<sup>a</sup>Ramboll Finland Oy, P.O. Box 718 FI-33101 Tampere, Finland

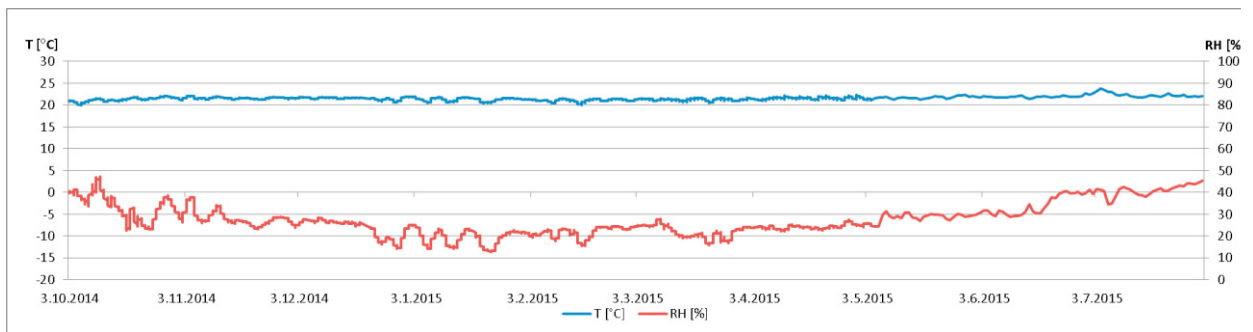
Sensors in group #1 were located in the 10 mm thick mineral wool between interior concrete frame and polyurethane insulation. An example graph is shown in fig. 4. The temperature in the mineral wool was app. +20°C around the year and relative humidity was between 20-50% depending on the heating season. The measured temperature matches closely the assumed inside temperature (+22°C). The heating season was also observable from the data: From October, the measured temperature was steadily between +21°C and +23°C, and at the same time the relative humidity in the mineral wool dropped from 45% to 20%. When the heating season ended in mid-April, measured relative humidity started to rise again and the peak values were reached between September and October.

In the measurement location 88 temperatures were slightly lower than in other measurement points. This might be explained by lower inside temperature in the adjacent room or air leaks in the wall assembly.

Relative humidity values higher than 85% were not detected in the data. This indicates that the conditions do not allow microbial growth based on the mold model in the material which has mold sensitivity classification 3, 'medium resistant'.

Fig. 4 The results from the sensor group 90, sensor #1, in mineral wool thermal insulation.

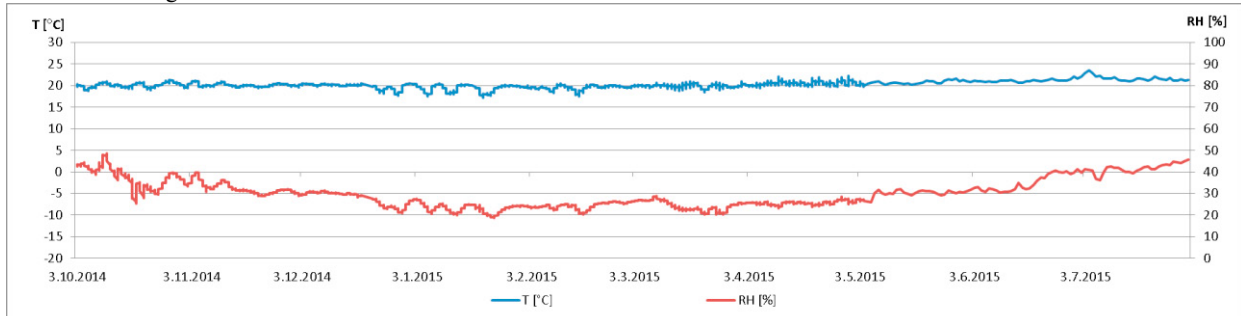
Sensors in group #2 were located in the 50mm thick polyurethane insulation. An example graph is shown in fig. 5. The temperature in the polyurethane was ca. +20°C around the year and relative humidity was between 15 and 50% depending on the heating season. The heating season was observable also from this data, when the relative humidity dropped from 50% to 20% between October and April. During summer the relative humidity values were higher and the peak values (app. 50%) were reached between September and October. Additionally, it was observed that the moisture in this layer was mainly originating from the inside air of the building, because the relative humidity followed the same graph as the sensor group 1 in the mineral wool layer. Therefore it can be concluded that the aluminum foil backed polyurethane layer prevents the outside air moisture from penetrating the structure and it functions as a vapor barrier as planned.

In the measurement location 88 temperatures were slightly lower than in other measurement points as noticed also in sensor 1, and is therefore logical.

Fig. 5 The results from the sensor group 90, sensor #2, aluminium packed polyurethane.

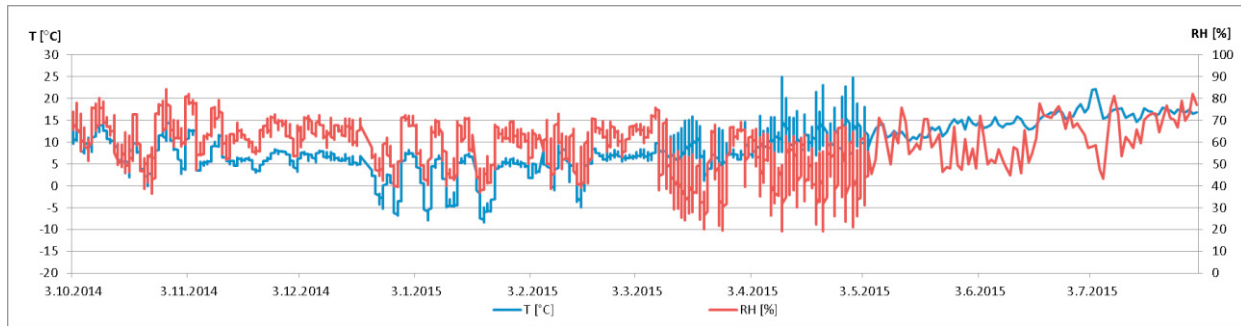
Sensors in group #3 were located in the 30mm thick mineral wool insulation, which performed as a fire resistant layer. In this layer the temperature graph follows the temperature measured from the ventilation air gap. An example graph is shown in fig. 6. During winter the temperature dropped below 0°C and in the summer the temperature was around +20°C. The circumstances which are critical for mold growth were not observed during the measurement period. Relative humidity was below 85% the whole time (and mostly below 80%, excluding short periods in few cases). The layer is also situated outside of the vapor proof polyurethane layer, which effectively prevents any impurities in the mineral wool wind barrier to enter the inside air.

Fig. 6 The results from the sensor group 90, sensor #3, fire resistant layer.

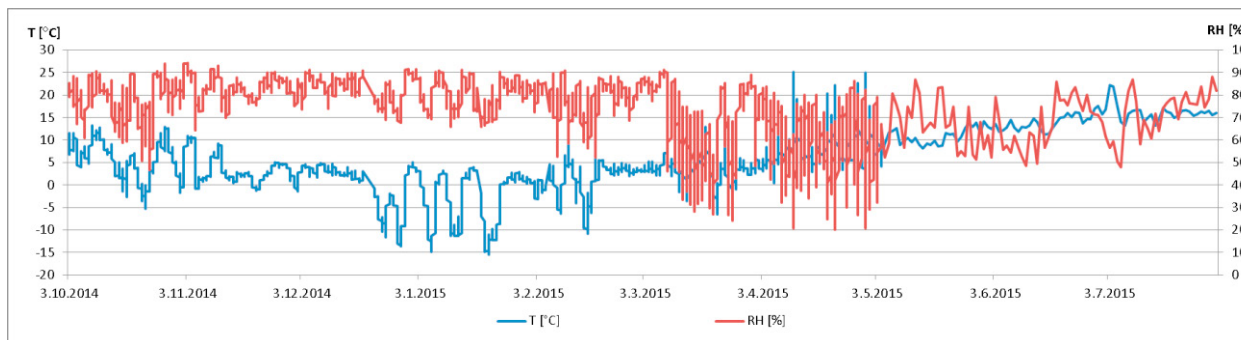
Sensors in group #4 were located in the 40mm air gap between the wind barrier and the facade brickwork. An example graph is shown in fig. 7. The sensors recorded relative humidity readings higher than 85% year around. This does not indicate direct risk of mold contamination, because the moisture is originating from outside air. It is shown in fig. 8. In typical Finnish outdoor climate the relative humidity is over 85% between September and April. It has been proven empirically that a wall structure with an air gap works correctly in these conditions. Furthermore, this kind of wall structure is following the current Finnish building codes in force.

Fig. 7 The results from the sensor group 90, sensor #4, ventilation gap.

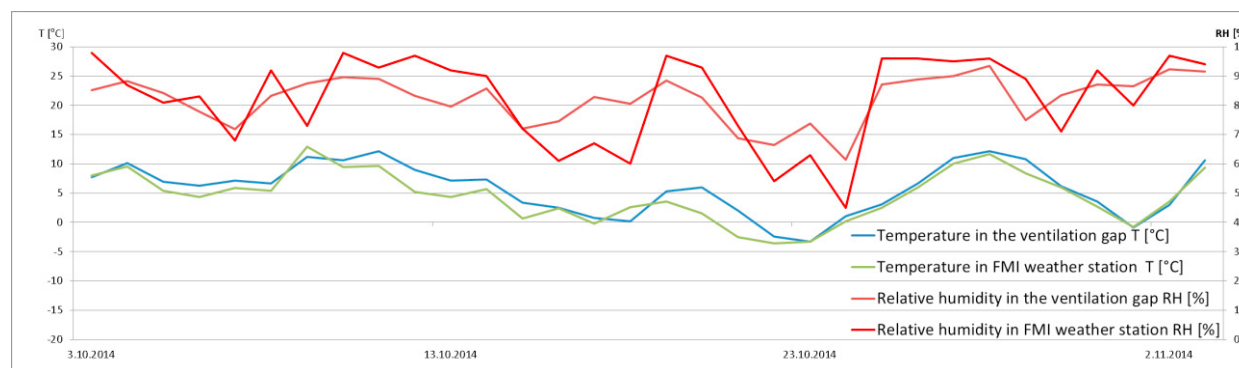
Fig. 8 The results from the sensor group 90, sensor #4 compared to outside air temperature and relative humidity [10]
