## Need to repair moisture- and mould damage in different structures in finnish public buildings

Annala, P., Lahdensivu, J., Suonketo, J., Pentti, M., & Vinha, J. (2018). Need to repair moisture- and mould damage in different structures in finnish public buildings. *Journal of Building Engineering*, 16, 72-78. <https://doi.org/10.1016/j.jobe.2017.12.010>

1 **NEED TO REPAIR MOISTURE- AND MOULD DAMAGE IN DIFFERENT STRUCTURES IN FINNISH PUBLIC**  
2 **BUILDINGS**

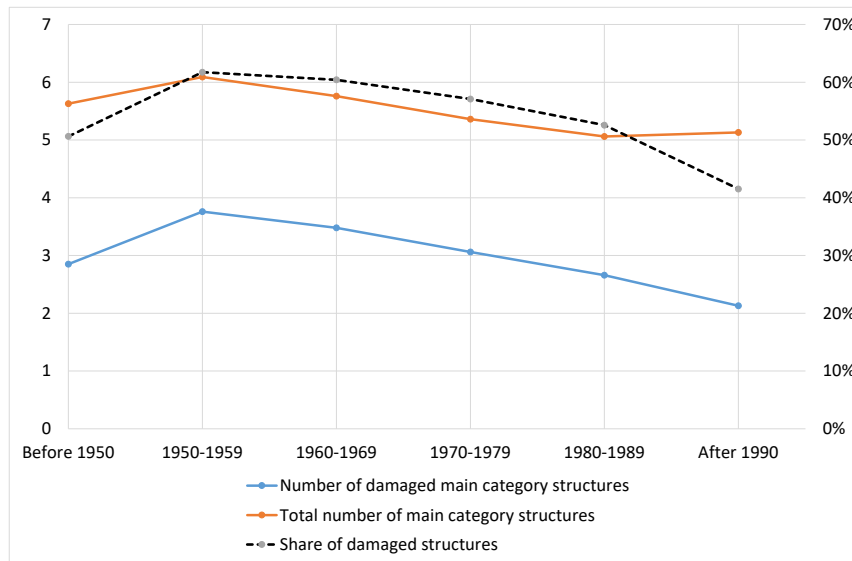
207 Figure 1. Number of damaged structures and total number of structures.

201 The results indicate that the buildings examined had suffered multiple damage, meaning that the need to  
 202 repair moisture- and mould damage was found in many different structures, as presented in Figure 1.  
 203 According to the structural classification, damage was found in all seven different main category structures,  
 204 as presented in Table 5. Figure 1 also illustrates the average number of main category structures and share  
 205 of damaged structures in different age groups.

208 The number of damaged main category structures in the entire body of research was 3.1 damaged  
 209 structures per building. The value is highest in buildings from the 1950s, with on average 3.8 different  
 210 structures being moisture- or mould-damaged. The share of damaged structures was 62% of the total  
 211 number of structures in these buildings. After the 1950s, the trend of number of damaged structures and  
 212 trend of total number of structures decreases. Moreover, when the share of damaged structures of the  
 213 total number of structures is evaluated, the trend also decreases in buildings built after the 1950s. It seems  
 214 that newer buildings are simpler than older buildings and one reason for this is that newer buildings are  
 215 more often built without a basement. They are also more rectangular in shape and simpler in terms of  
 216 architecture. Basically this means massive single-material structures or at least fewer different materials.

217 Figure 1 clearly demonstrates that in newer buildings the need for repair of moisture- and mould damage is  
 218 rarer than in older buildings.

219 Buildings built before 1950 are a little bit simpler than newer buildings in terms of total number of main  
 220 category structures. This group is also more heterogeneous than other age groups considering the age of  
 221 building, as presented in Table 3. It is also probable that most damaged buildings from this oldest group are  
 222 not in use anymore. In summary, these factors probably explain the deviation from the trend of the other  
 223 age group.

286 The trend of the number of moisture- and mould-damaged structures is almost linear, if we ignore the  
287 oldest building group '*before 1950*' and draw linear regression into Figure 1. As mentioned before, the  
288 group '*before 1950*' is quite a heterogeneous group of buildings and it is probable that the most damaged  
289 buildings are not in use anymore. This may be why this group differs from other groups as presented in  
290 Figure 1. The direction of the trend is as supposed: the need for repair is greater in older buildings, also in  
291 terms of moisture and mould damage.
