# Detection of gear pitting failure progression with on-line particle monitoring

## Abstract

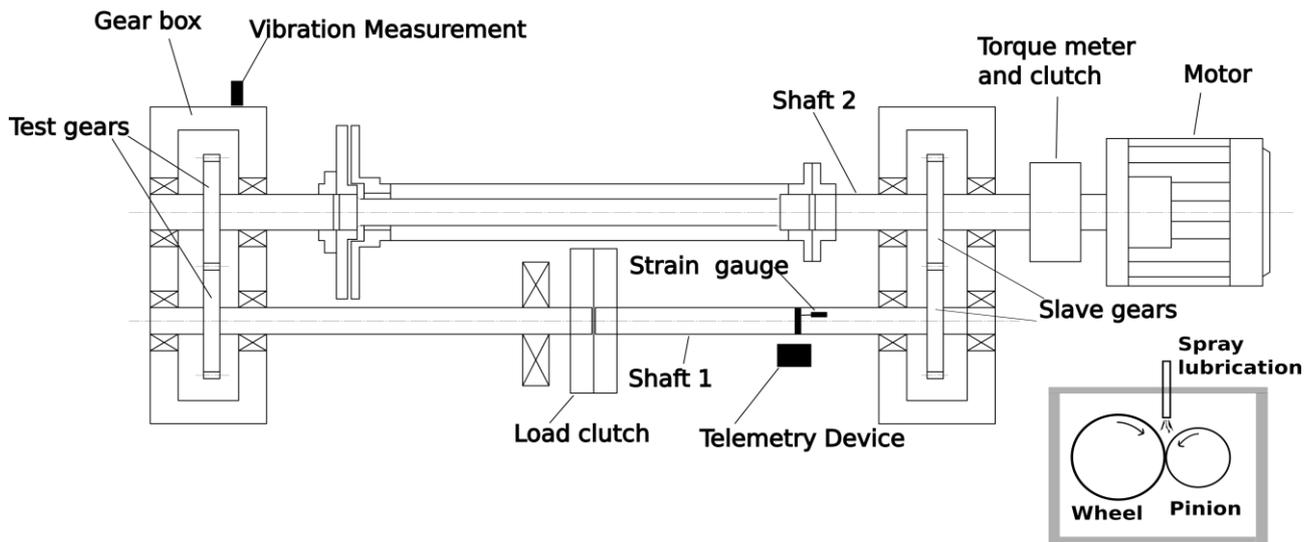
Gear tests were carried out using a modified FZG test device, which is shown in (Fig. 1). The loading of the test gears can be adjusted by applying appropriate torque to shaft 1 through the load clutch using weights and a rod. The applied torque is measured on-line from shaft 1 with strain gages and telemetry device. The required power is fed with an electric motor, of which adjustable rotating speed is controlled by frequency converter. The rotational speed is measured from shaft 2 with a pulse sensor. The system friction torque is measured with torque transducer from shaft 2.

Figure 1. Principle of the test rig.

The gears and bearings are lubricated using pressurized circulating (spray) lubrication so that the spray is directed with the direction of rotation of gears as shown in Fig. 1. The test and slave gears have their own lubricating systems. The flow chart of the lubrication system of the test gearbox is shown in Fig. 2. Oil fed into the test gearbox is filtrated with 6  $\mu\text{m}$  filter. Cleanliness of the inlet oil is measured from a side flow using an optical particle counter. Particles larger than effective diameter of 4  $\mu\text{m}$  are detected and the results are classified to three different size classes according to ISO 4406 standard. Particles in outlet oil are observed on-line with an inductive metallic contaminant sensor. Ferrous particles larger than the effective diameter of 70  $\mu\text{m}$  and non-ferromagnetic metallic particles larger than the effective diameter of 200  $\mu\text{m}$  are detected. The sampling intervals of the particle monitoring in both cases are one minute.

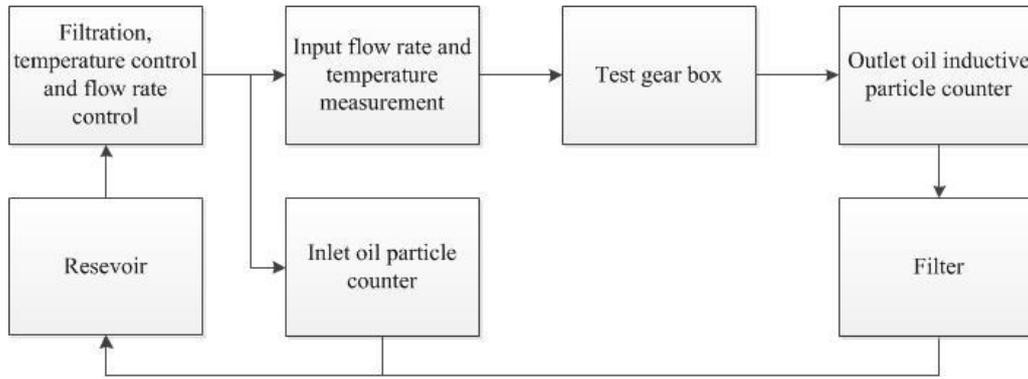
**Figure 2.** Basic principle of the lubrication system used in test gear box.

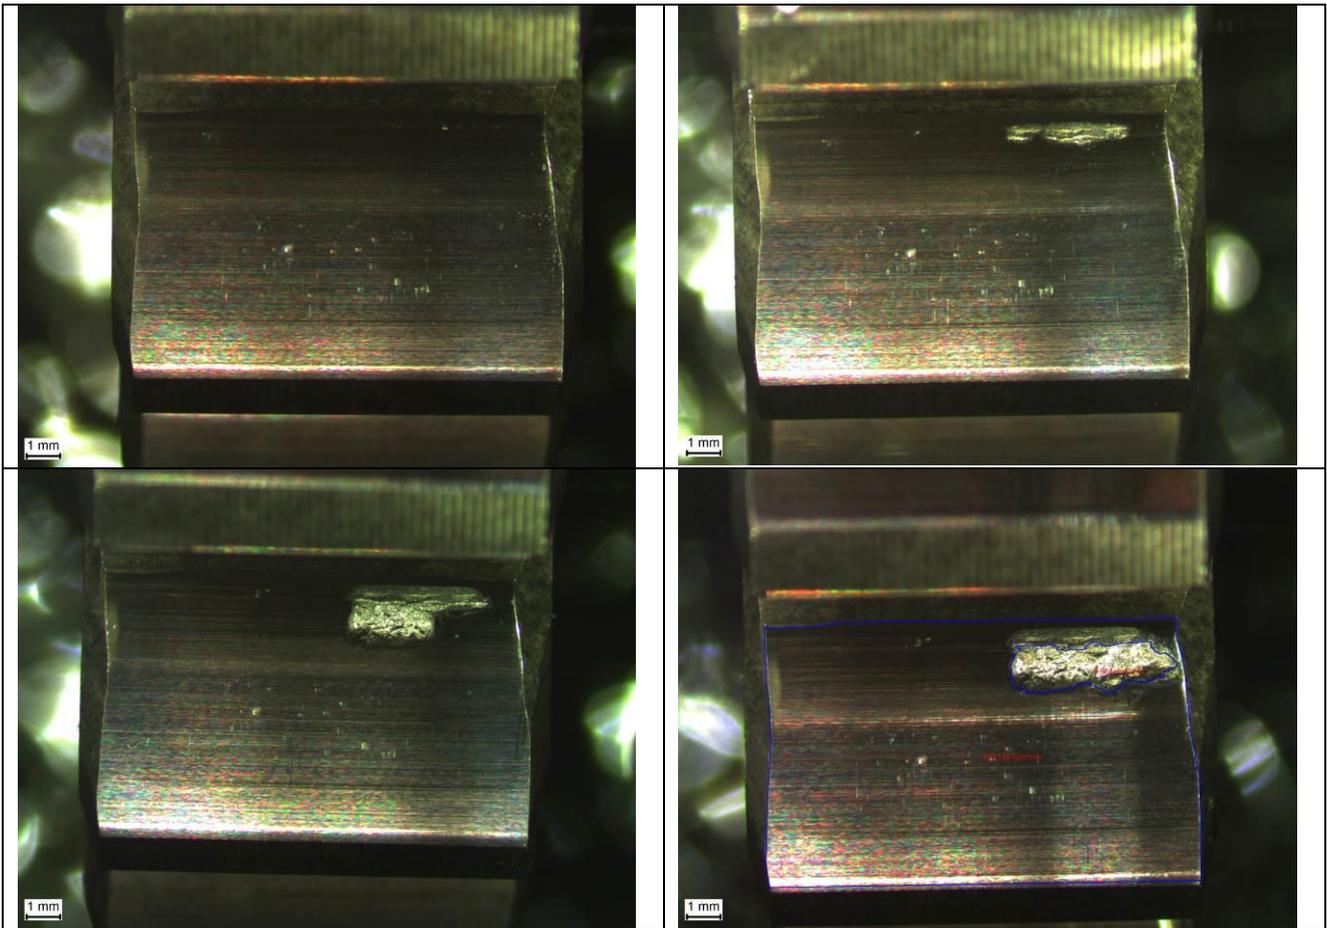
The visual inspections and photographs were taken after 2.50, 5.00, 7.50, 10.00, 10.76 and 10.84 million cycles on test load of which four is shown in Fig. 3. Fig. 3a shows that after 2.5 million load cycles only very minor scars can be observed in the middle of the flank. The orientations of these scars are in the direction of flank rolling and sliding indicating that they are caused by wear occurring most probably during the start-up, which was done in loaded condition. In any case, running-in of the gears can be considered to be successful. The first signs of micropitting were observed in the root of the pinion in the visual inspection made after 5 million load cycles (not shown in figure). Early signs of macropitting were observed in 10.0 million load cycles as shown in Fig. 3b. Most part of the appeared scar can still be classified as micropitting (grey areas), but the deeper and brighter small areas are already the first symptoms of macropitting even they damaged area compared to the total active flank area is still close to zero. This figure also indicates that the initiation of macropitting is promoted by micropitting as it originates in the same region where micropitting had already occurred. After initiation, the damaged area related to macropitting increases rapidly being 3.3 % in 10.76 million load cycles and 5.7 % in 10.84 million load cycles as shown in Figs. 3c and 3d, respectively. In this stage, the damaged area caused by macropitting had reached over 4 % of the single active tooth flank and the test run was stopped. Macropitting occurred mainly in two adjacent flanks in pinion. The flank presented (Fig. 3) was dominant in size of the macropitting damage. Damages in pinion caused some visible damages to the corresponding wheel teeth. Further on, damages in wheel also caused some minor damages to other two pinion teeth mating with damaged wheel teeth.

**Figure 3.** Progression of macropitting. Pinion teeth after 2.5 (stage 0) (up left), 10.0 (stage 1) (up right), 10.76 (stage 2) (lower left) and 10.84 (stage 3) (lower right) million load cycles.

The comparison of the results obtained from the visual inspection and particle on-line monitoring are shown in Fig. 5. The overall trend view is that the results correspond well. After 2.5 million load cycles the gear flank is practically undamaged (Fig. 3a) and the corresponding on-line monitoring showed no particles during loaded run before that time. During the time of micropitting, 5-10 million load cycles, first symptoms of macropitting arose (Fig 3b), but the damage area related to macropitting remained still very small. Correspondingly occasional single particles can already be observed from on-line monitoring. At the end of the run, the number of particles is increasing progressively, which can also be seen in the visual inspection as rapidly increasing damaged area in active gear flank.

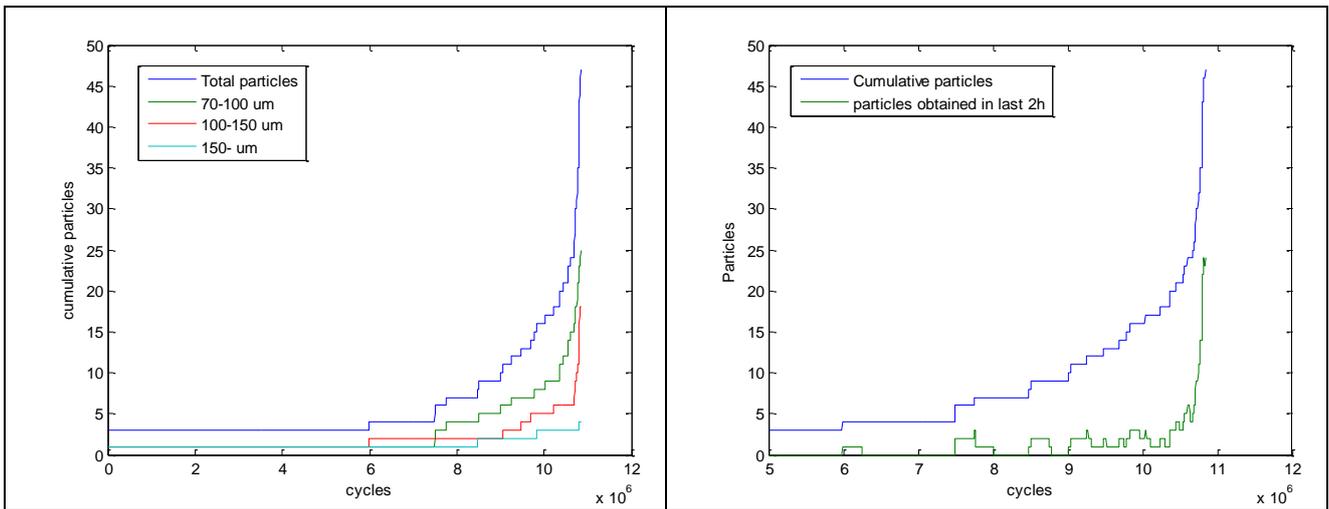
The results of continuous on-line particle monitoring from oil outlet in the range of 0 - 10.84 million load cycles is shown in Fig.4. The ferrous particles larger than 70  $\mu\text{m}$  in outlet oil were measured and classified to the three different size classes as shown in Fig. 4a. Three particles have bypassed the counter during the first running-in stage, but no further particles were obtained until 6 million cycles and micropitting had already appeared. In this stage some particles were detected, even the size of micropitting particles can be considered to be less than 70  $\mu\text{m}$ . However, Fig. 4b shows that particles observed during last 2 hours, i.e. 270 000 load cycles, produce only occasional single occurrences until after 9 million load cycles they become more regular, but still being mainly single particles. After load cycles of 10.4 million progressive particle production appeared and nearly stepwise increase occurred in 10.7 million load cycles. About 55 % from the total number of particles were obtained during the last 300 000 cycles. Fig. 4a shows that main share of the particles belongs to the smallest size class (70-100  $\mu\text{m}$ ), but in later part of the run, where the progressive macropitting occurred particles of size larger than 150  $\mu\text{m}$  already appeared.

**Figure 4.** Ferrous particle accumulation measured from outlet oil (left). Accumulated particles and particles observed in last two hours (right).

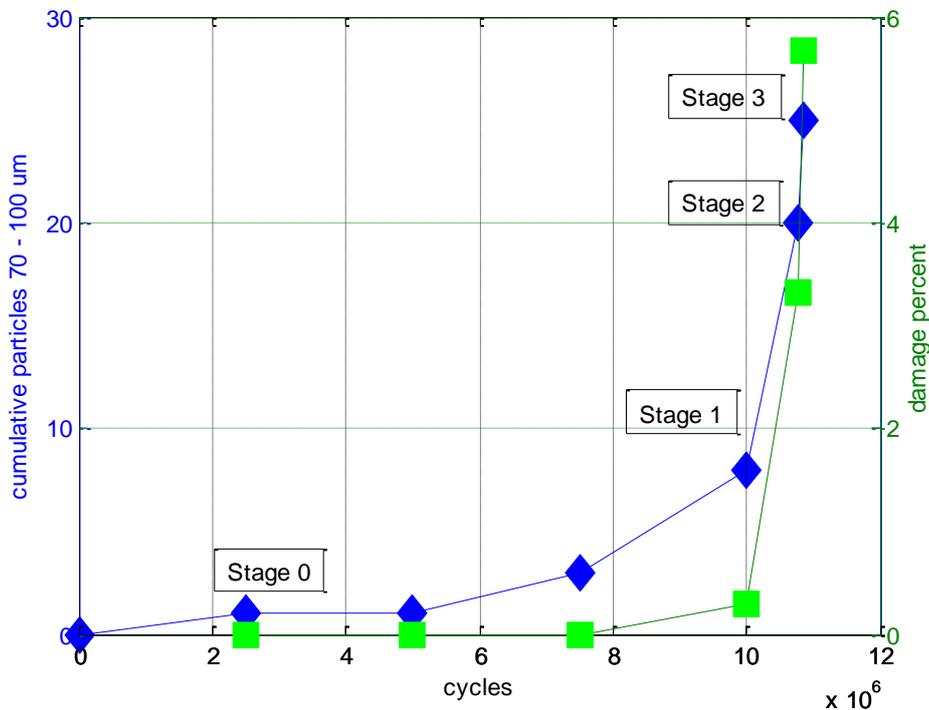
**Figure 5.** The comparison of the gear flank damaged area and the measured particles in oil outlet as a function of load cycles. Visual inspection points are dotted. Stages 0 ... 3 represent vibration analysis points.

In Fig. 6 the results of vibration acceleration signal descriptor values in four different running stages are presented. The number of loading cycles of each running state is presented in Fig. 5. Analysis frequency bands are 5 Hz ... 5 kHz which is whole analysis area, 1 kHz ... 3 kHz describing the area of multiple meshing frequency, 0.4 kHz ... 0.8 kHz which is the area of meshing frequency and sideband frequencies and their multiples, rotational frequency area 20 Hz ... 40 Hz and amplitudes in rotational frequencies of the shafts. The results show that the trend of all descriptors is rising. The strongest correlation between descriptors and gear wheel wear stage is in vibration meshing frequency band 0.4 kHz ... 0.8 kHz. Most sensitive descriptors were Kurtosis and Crest Factor values. These results tell that the fault in gear wheel generates impact pulses in the vibration acceleration. Form Factor indicated very weakly. The vibration amplitudes at rotational frequency 25 Hz and 37 Hz rose also very clearly along the wear progress. The wear in gear wheels may influence on the roundness of the pitch cone which generates stronger vibration at rotational frequency.

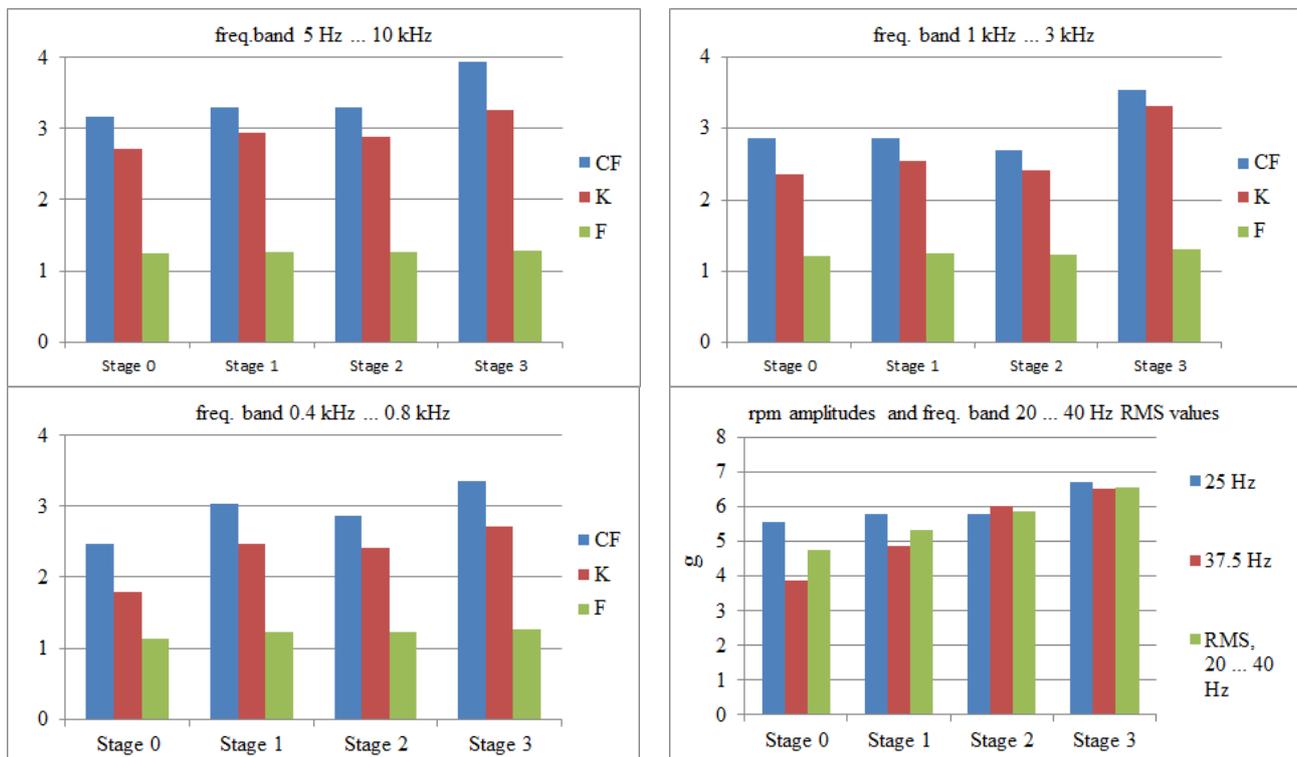
**Figure 6.** Values of descriptors extracted from vibration acceleration in different fault stages.

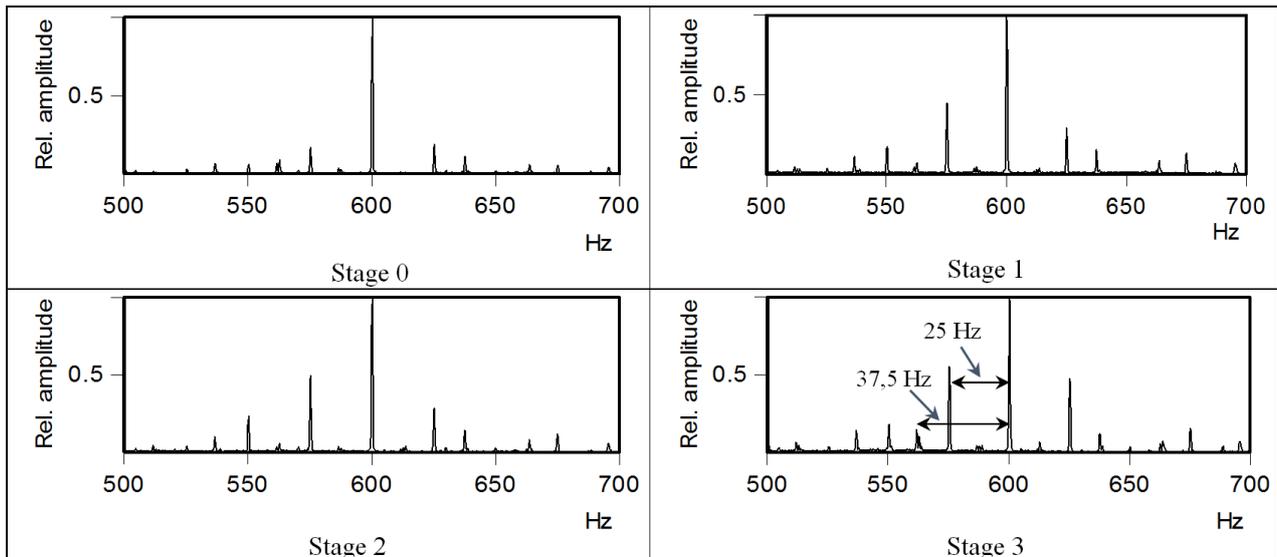
In Fig. 7 the spectra in frequency band of 500 Hz ... 700 Hz, which is the area covering meshing frequency, sidebands and their multiples are shown. The spectra are scaled relative so that meshing frequency amplitude has value of 1. This has been done, because the interesting thing is relative amplitudes between meshing frequency and sideband frequencies and number of sidebands. Some sidebands are visible in spectrum of stage 0. However, there is a very clear difference in sidebands already between stage 0 and wear stage 1. In stage 2 and 3 the amplitudes of sideband have still a little bit risen.

**Figure 7.** Spectra in frequency band of 0.5 kHz ... 0.7 kHz in different fault stages. Meshing frequency is 0.6 kHz and sidebands  $\pm 25$  Hz and  $\pm 37.5$  Hz and their multiples.
