Municipal challenges in managing a building with noted health symptoms

Paper type Case study

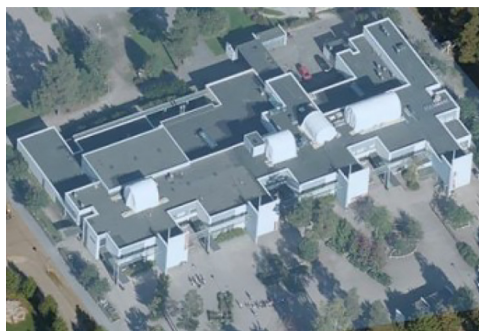
Plate 1.
Aerial view of the
building (feasibility
analysis)

hollow-core concrete slabs as its load-bearing structure. The roof was repaired during 2015-2017. The building has a mechanical supply and exhaust ventilation ([Plate 1](#)).
