Experimental behaviour of stainless steel cellular beam in fire

NORDIC STEEL 2019
The 14th Nordic Steel Construction Conference,
September 18–20, 2019, Copenhagen, Denmark

Mikko Malaska^{*a}, Katherine Cashell^b, Mika Alanen^a, Kristo Mela^a, Sheida Afshan^b

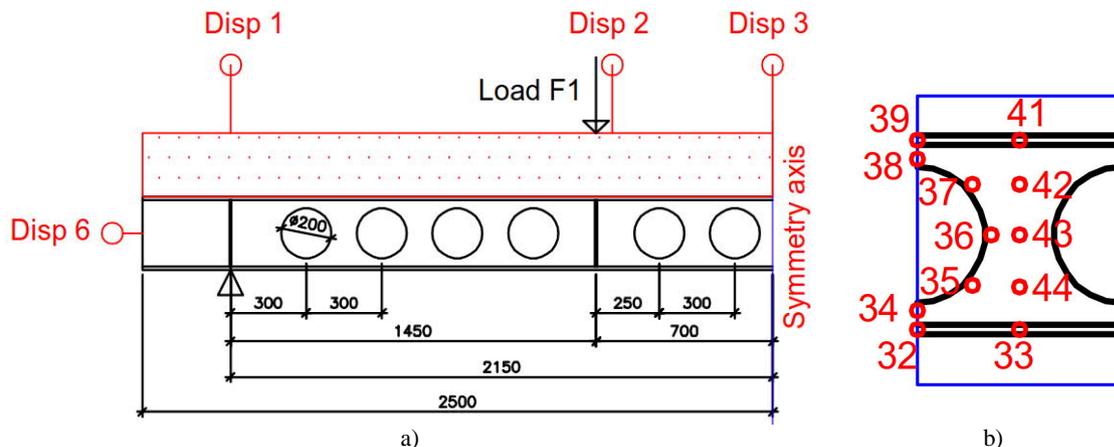
Fig. 1. a) Detail information of the beam and cell geometry, left half of the beam b) Thermocouple positions at beam mid-span.

The experimental research was conducted in accordance with European test standards SFS-EN 1365-3 (6) and EN 1363-1 (7). The steel beam was installed across the longer span of the 3 m × 4 m furnace chamber. The total length and span of the beam were 5000 mm and 4300 mm, respectively, and the length exposed to fire was 4000 mm. Both beam-ends were simply supported and one end on roller support. The symmetrical 290 mm deep by 300 mm wide beam section was fabricated from stainless steel plates of grade 1.4301. The beam flange and web thicknesses were 14 mm and 8 mm, respectively. The size of the web to flange welds were 5 mm. Web stiffeners 8 mm thick were provided at the beam supports and at the load application points on both sides of the web. The diameter of circular openings were 200 mm and they were located at 300 mm centers. *Fig. 1a*) shows the beam and opening geometry. The beam was not fire protected.

Fig. 3. Steel temperatures at mid-span a) Over beam cross-section; b) Web temperatures. For thermocouple positions refer to Fig. 1b).

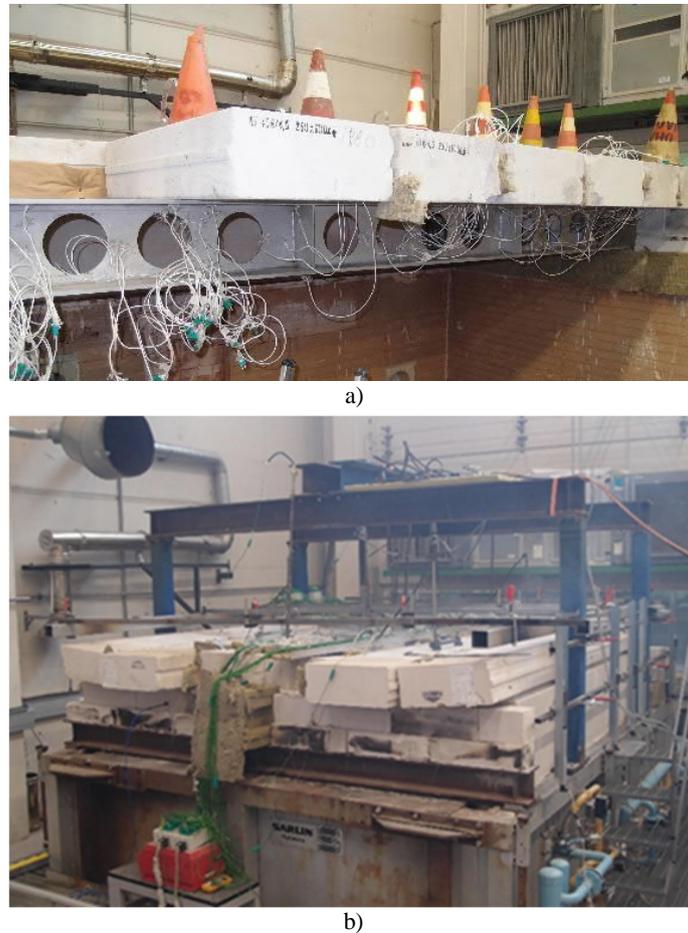
Fig. 2. a) Beam and slab construction during installation; b) Test set-up during the test.

The horizontal slab construction over the furnace chamber and the test beam was made up of 250 mm thick aerated concrete blocks and elements. Concrete blocks were placed on the upper flange of the beam, in order to simulate the floor and provide three sided heating. The 1200 mm long blocks were installed with their longer dimension perpendicular to the beam span, see *Fig 2a*). The remaining area of the furnace chamber was covered with aerated concrete elements spanning parallel to the steel beam.

The beam was tested under two point-loading. Constant loads of 58 kN were applied through hydraulic loading jacks fixed to a load application frame above the test furnace, as shown in *Fig. 2b*). The test load was considered to be approximately 30 % of the ultimate load found from pre-design calculations made at ambient conditions. In addition, the self-weight of the concrete blocks bearing on the beam was approximately 1.5 kN/m. The beam was continuously loaded to the test load for

The fire test was performed in accordance with SFS-EN 1365-3 (6). *Fig. 2b*) shows the test set-up during the fire test.

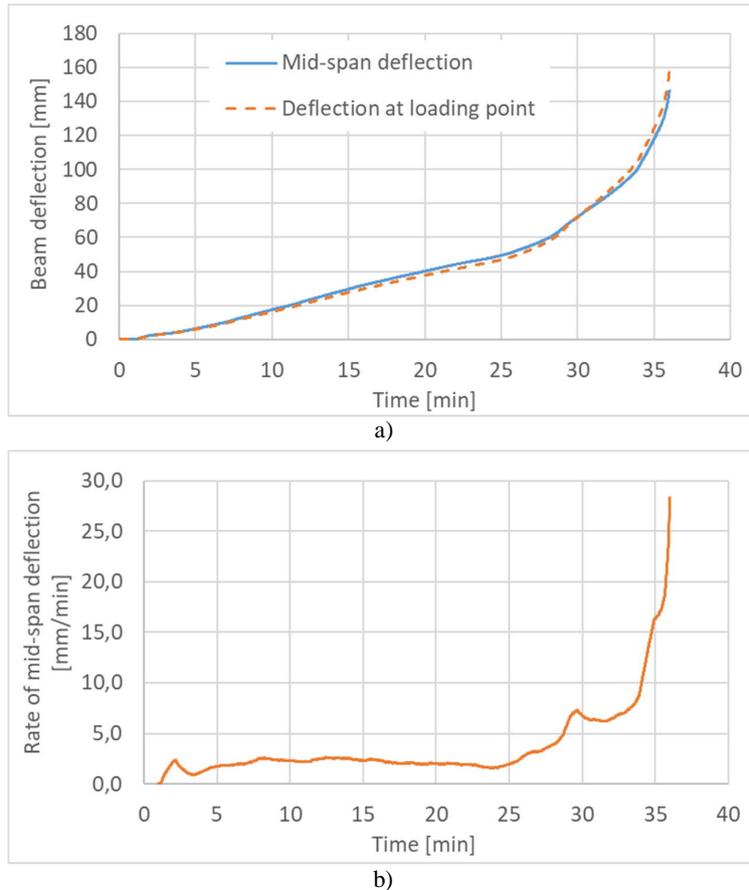
Fig. 3. a) Beam deflection at mid-span and loading point; b) Rate of mid-span deflection

The performance criteria for the beam load-bearing capacity is defined by the limiting value of deflection and limiting rate of deflection (7). In this test the limiting values were 159 mm and 7,1 mm/min, respectively. The measurements taken during the tests are presented in *Fig. 3*. It is shown that in terms of the mid-span vertical deflections, the beam responded linearly until about 24 minutes by which time the furnace temperature had risen to over 800 °C. After this point, the rate of deflection began to gradually increase due to the deterioration of the beam properties. At about 28 min the rate

of deflection started to increase and the limiting value for the rate of deflection was exceeded 29 minutes after ignition. By that time, the beam had deflected 65 mm and the furnace temperature was around 840 °C. The rate of beam deflection started to increase rapidly 34 minutes after ignition and the burners were shut off 36 minutes after ignition when the maximum beam deflection exceeded the limit value of 159 mm. The maximum deflection occurred at the load application point. The testing standard EN 1363-1 (7) and the fire resistance classification standard EN 13501-2 (8) give two different assessments for the beam loadbearing capacity R. The first standard states that the capacity is reached as soon as one of the two criteria is exceeded, which in this test gives fire resistance classification R20. In accordance with the classification standard failure to support the load is deemed to have occurred when both of the criteria have been exceeded, leading to classification R30 in this test.

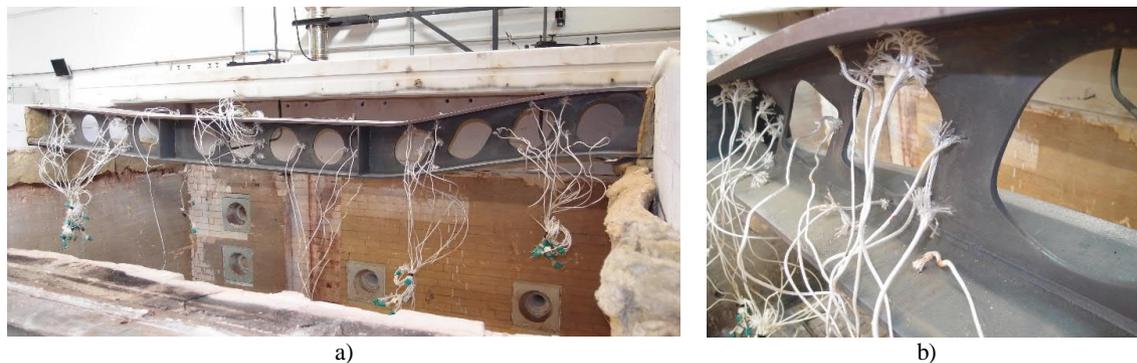
Fig. 4. a) Steel beam after testing; b) Web post buckling failure mechanism

The failure mechanism of the beam was buckling of the web posts between the load application point and the beam support. Fig. 4 shows the deflected shape of the beam after testing and the failure mode forming an S-shape on the web between openings. As described above, the beam responded linearly until about 24 min at which point the maximum and average beam web temperatures were 703 °C and 672 °C, respectively. Failure occurred around 5 minutes later when the maximum web temperature had increased to 785 °C and the average web temperature was 759 °C. At this average temperature, Young's modulus and the material strength ($f_{2,0}$) are reduced to 66% and 43%, respectively, of their value at 20 °C (9). For carbon steel at 759 °C temperature the corresponding reduction factors are significantly lower being 16% and 11% for the effective yield strength and the slope of the linear elastic range, respectively (10).
