Uotila, U., Saari, A., & Junnonen, J-M. (2020). Decision-making when organising facilities for a school: a participatory action research approach. *Facilities*. <https://doi.org/10.1108/F-10-2019-0113>

# Decision-making when organising facilities for a school: a participatory action research approach

Ulrika Uotila, Arto Saari and Juha-Matti Junnonen  
*Faculty of Built Environment, Tampere University, Tampere, Finland*

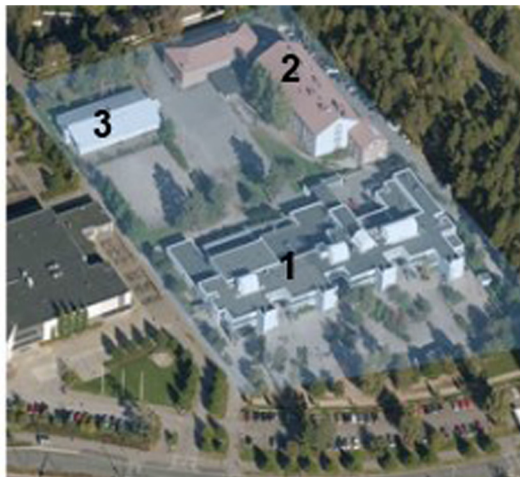
**Figure 1.**  
The case-campus is light-coloured and the numbered buildings are (1) the white building, (2) the brick building and (3) the pavilion

The case study concerns a school campus that consists of three buildings: the so called white building, the brick building and the pavilion, located in the Vantaa metropolitan area, Southern Finland. All the pupils use each of the buildings and in total there are almost 800 pupils using the campus (Figure 1).
