ESD and Disturbance Cases in Electrostatic Protected Areas

50 Words Abstract – Electrostatic protected area (EPA) can effectively prevent ESD failures from charged operators, work benches and tools. However, electrical disturbances and ESD events from other sources can still exist in well-built EPAs. In this paper failures found in electronic assembly environments are analyzed to improve coverage of ESD control programs.

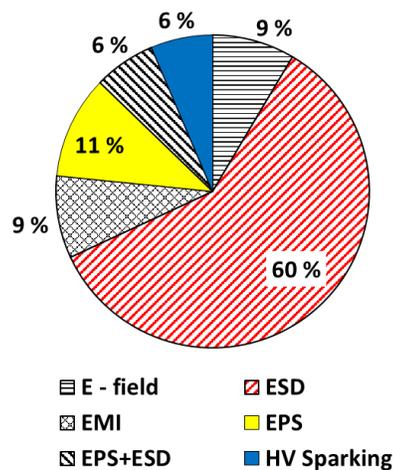
The failure cases are analyzed by using three categories; source, event type and victim. The first category explains possible sources for failures based on the following items: static E-fields, ESD, EMI, External Power Supply (EPS), and a High Voltage (HV) source. The observed failure sources with the percentage information of the total are presented in Figure 1.

Figure 1: Observed failure sources.

The largest failure group in Figure 1 is ESD, which has been categorized when a direct ESD between the victim device and another object has caused the failure event. E-field is the source for example when an electrostatic force cause failures. HV is selected when the voltage alone is the source of a failure. HV and EMI are categorized as the source when, for example, HV cable sparking generates EMI pulses and the radiated RF noise disturb equipment operation.

Figure 1 shows that more than half of the observed failure sources in EPA have been ESD events even though the EPA might be expected to prevent ESD from taking place. EMI and problems with power sources represent together about 25 % of the observed failure sources. Static E-fields and HV sources represent less than 15 % of the cases. This analysis suggests that a typical ESD control program may only partially cover E-field and ESD event detection, whereas HV sources and EMI detection can be easily overlooked. EPS sources can be challenging to detect as these depend strongly on the type of products and equipment used. In our experience the external power source has typically been a product tester, battery or programming equipment. Here the correct operation of software plays also a major role as the failure may occur only when the product is in a specific operation mode.

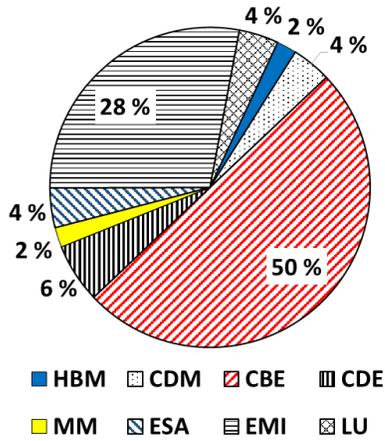
The second category shows a statistical distribution of failure event types based on the commonly used models; Human Body Model (HBM), Charged Device Model (CDM), Machine Model (MM), Cable Discharge Event (CDE), Latch Up (LU), and Charged Board Event (CBE). These events involve an electrical contact with charge transfer occurring. In addition, we use two additional event types based on Electrostatic Attraction (ESA) and failures due to radiated RF noise marked with EMI. The type and share of failure events is presented in Figure 2.

Figure 2: Event type leading to a failure.

CBE is the most common failure event type in Figure 2. This is not surprising as subassemblies, PCBs and mechanical components are the most common parts handled in electronics assembly process. EMI events represent about one third of all the events leading to failures. This is consistent with the several testing phases typically required during electronics assembly, programming and qualification. Some of these testers are often built in-house and are not subject to EMC immunity or emission qualifications. The process area may also have a high variety of tools and equipment producing periodic EMI pulses or radiating RF noise to the close environment. Therefore, ESD or LU events are not the only source or event type leading to EMC related failures in an EPA.

The rest of the events in Figure 2 represents each less than 6 % of the total. However, HBM, CDM, MM, LU, CDE, and ESA together cover about 20 % of all the failure events. Therefore, it is important to evaluate these event types when optimizing EPA control.

There is also one HBM event in Figure 2. In this case the source of the event was a charged system periodically discharging into a neutral person with mega Ohm range grounding. Thus, the discharge event was similar to a real life HBM, but the source of the failure was not a charged person.

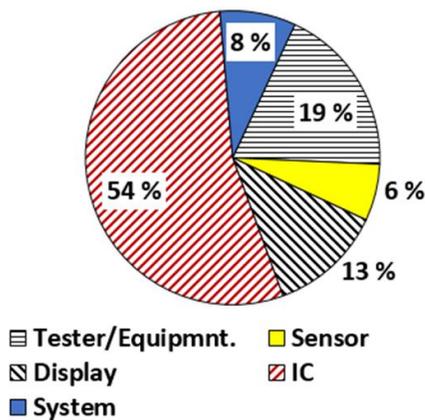
The third category is the type of failing victim in EPA based on the first and second category. However, it is not always as straightforward to define a single victim for a failure. For example, RF noise can couple via a cable and through several components on a printed circuit board (PCB) before it reaches the IC that may finally produce the failure. Therefore, a specific IC has been selected to be the main victim only when failure analysis have proven the failure to exist inside the IC. In other cases the victim is selected based on the module where the failure was observed. A sensor and display module are selected as their own group as those can be typically tested separately, and a whole system is marked as the failing part when more detailed information is not available. In addition, electrical testers and equipment used in the process area are counted as one group.

Figure 3: Failing items.

Figure 3 shows that in about 50 % of the failure cases one specific IC in the product was found to be the main victim. The failure was due to a physical defect or a major electrical disturbance leading to a product failure. In addition, electrical testers and equipment have failed in about 20 % of the cases. This is once again related to the amount of EMI events and number of testing phases occurring in the EPAs.

Displays and other electrical sensors have failed in about 20 % of the cases. Many of the electrical systems have a display or sensors integrated, and these can be susceptible to both ESD and electrical disturbances due to EMI. In electronic assembly these components are still open and accessible for processing which increase ESD and EMI risks. Displays contain also large dielectric plastic or glass surfaces that can be easily charged for example by peeling off a temporary protection film. These surface charges may trigger ESD or ESA events leading to product failures.

The rest of the failures in Figure 3 are counted as system level. In this case the failure has been a complex combination of mechanics and electronics and it has been challenging to define a single failing component.

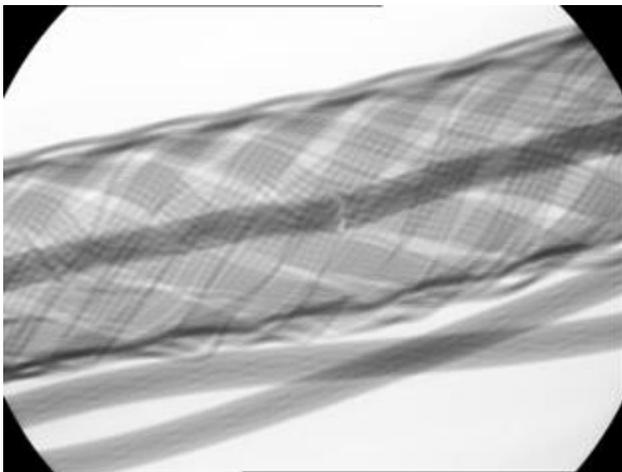
During the usage the HV cable type *B* inside the bundle became physical damaged around the cable bending areas, as can be seen in Figure 4. The cable and ionizer still operated according to the specification, but the broken cables started to emit EMI pulses due to the sparking between the middle HV wire and a shield conductor. Some of the cables had cracks also along the center conductor. The

generated RF noise radiated and coupled into product testers a few meters around the workbench and produced test failures. With some testers the testing failure rate was tens of percent's.

Figure 4: X-ray image of a broken high voltage cable.

All the HV cables were changed to more robust type A and that solved the failure case.

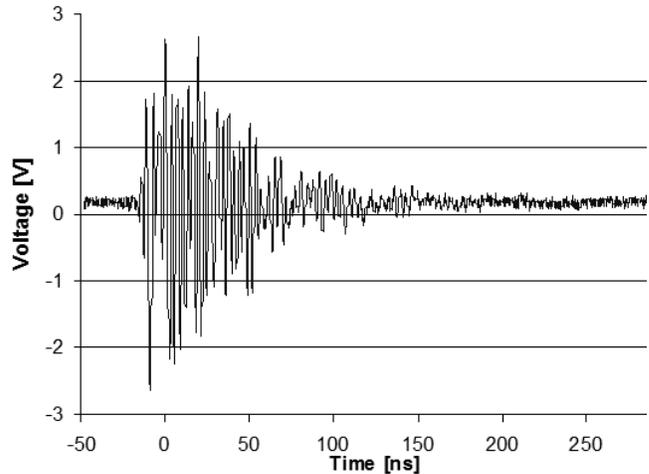
A Sanki EMI Locator tool was used to locate the source of RF noise. The detector was able to sense the broken cables a few meters distance, and by bringing the detector beside the cable, damage locations were seen from the LEDs informing the signal amplitude. The broken cables were tracked also by using an oscilloscope and antennas, and an example measured waveform is shown in Figure 5.

Figure 5: Measured EMI pulse with a monopole antenna.

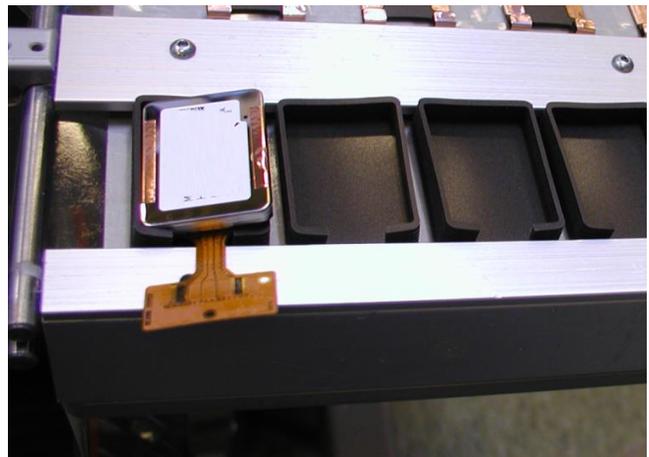
An electronic system had a small hard disk drive inside the enclosure. The hard disk was assembled with a rubber cushion material to protect the disk from excess accelerations and shaking. The disk and cushion material is shown in Figure 6.

Figure 6: A hard disk and dielectric black color cushion.

Hard disks were found to have electrical failures in a final testing phase and the supplier of the disk reported electrical overstress or ESD damage with control electronics based on failure analysis. The hard disk had reasonably good ESD protection design and was able to withstand ESD up to 4 kV based on IEC61000-4-2 qualification. The enclosure of the disk was conductive and the handling area had all basic EPA precautions in place. However, the cushion material was made of dielectric rubber and got triboelectrically charged when the disk slid inside.

When the operator placed the disk inside the cushion material, he/she grounded the disk via hand and only less than 100 V surface potentials were found on the metallic enclosure of the disk. However, when the assembly was picked up from the feeder the capacitance of the assembly decreased, thus, increasing the static potential over 1 kV. In addition, the measured charge in metal parts of the disk was more than 10 nC. During the next assembly phases the

There was an additional ESD risk scenario, which is visible also in the Figure 6. The flex connector was able to touch on the metallic surface of the feeder during handling. This was prevented by adding a piece of dissipative material on the contact area.

The failure case was completely resolved by spraying semi-conductive liquid on the cushion surface prior to the assembly. That reduced charging phenomena until the system was fully assembled. Later on, the dielectric cushion material was replaced with a dissipative version.

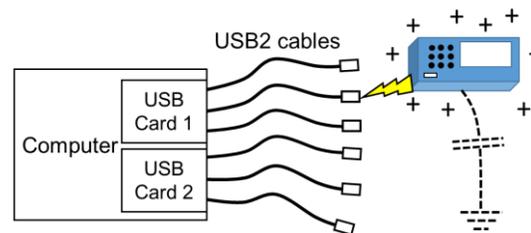
The product had a plastic casing and that charged up to a few hundred volts when it was manually handled in the programming phase. This induced around 5 to 10 nC static charge on electronics inside the casing. When a worker plugged a USB cable into the product an ESD discharge went through the cable into the computer as shown in Figure 7. This discharge was relatively weak, but initiated a latch up phenomena in the USB card that led to damage to USB control circuits.

The USB cable used had no extra ferrite bead EMC filtering. In addition, the ground shield of the USB wire was connected only in one end of the cable, thus,

Figure 7: LU failure triggered by an ESD event.

all the product charges discharged via the signal pins between the product and the USB card. The USB card had unknown EMC/ESD design and the primary corrective action was to improve EMC/ESD filtering with the data connection. The case was completely resolved by adding two low cost snap-on ferrite cores along the USB cable.
